# Manhole Inspection Summary

## Manhole # S17AA1006MH

Insp Date: **2/28/07 11:31 AM**

**Location** Address: **3524 GREENSPRING AVE** Cross Street: **PARK HILL AVE**

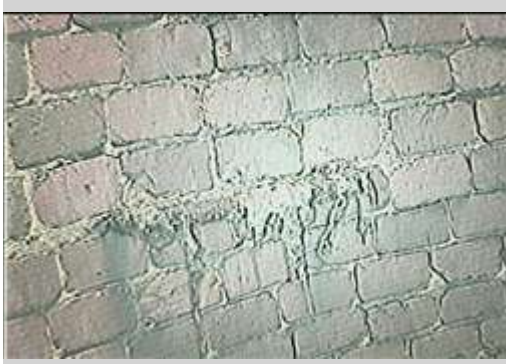
Evidence of surcharge - Bench debris.  
Corroded steps.

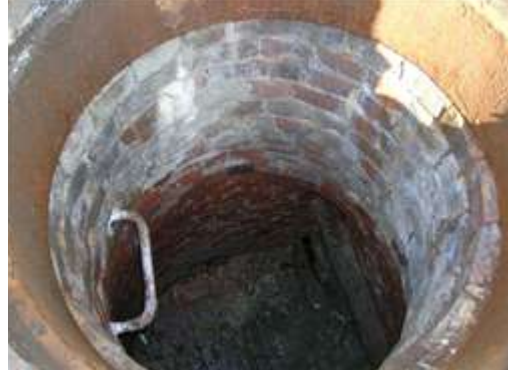
Defect

Frame leaks. Frame offset. Adjustment  
deterioration and infiltration - other side.

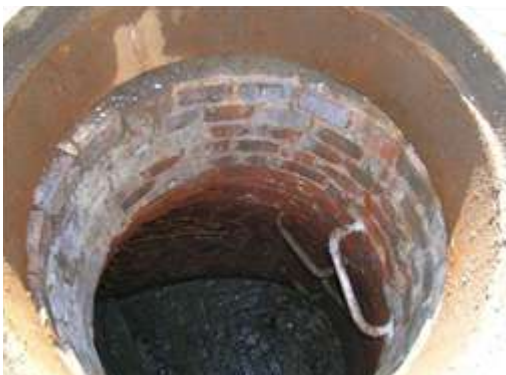
Defect

Frame leaks. Frame offset. Adjustment  
deterioration and infiltration.

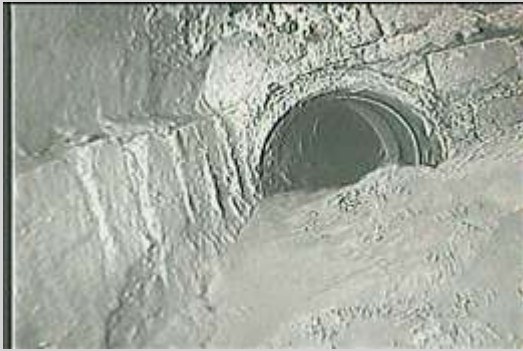
### 8 in. Circular Gravity Sewer Pipe Out @ 12 O'Clock

Infiltration: **Evidence** Pipe Seal Cond: **Unknown**

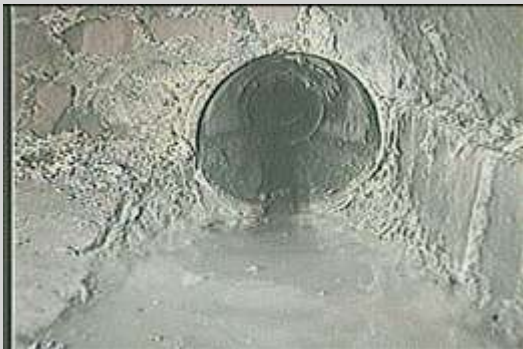
### 8 in. Circular Gravity Sewer Pipe In @ 6 O'Clock

Infiltration: **Evidence** Pipe Seal Cond: **Unknown**
